**Client Name:** Western Cape Government Department of Transport and Public Works

**Project Description:** The Western Cape Government (WCG) appointed Re-Solve to complete zoning, and leak detection to establish the location of a major leak at the Cape Teaching and Leadership Institute (CTLI).

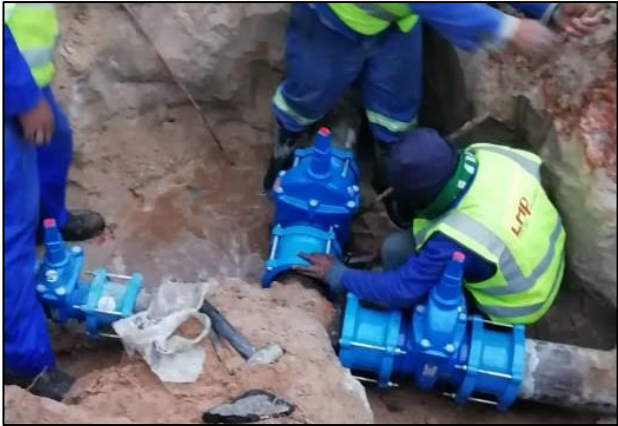
*Valve Replacements*

- **Valve Replacement Project** – After the initial zoning investigation, a valve replacement project was proposed and approved by WCG. The valve replacements were to ensure that proper zone isolation could be done to determine in which areas the leaks were located.

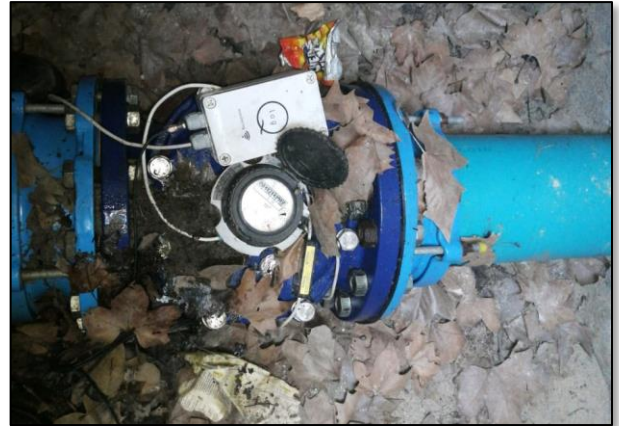
*Flow Logging*

- **Logging** – A flow logger was installed on the bulk water meter and pressure loggers were installed in the different zonal areas.

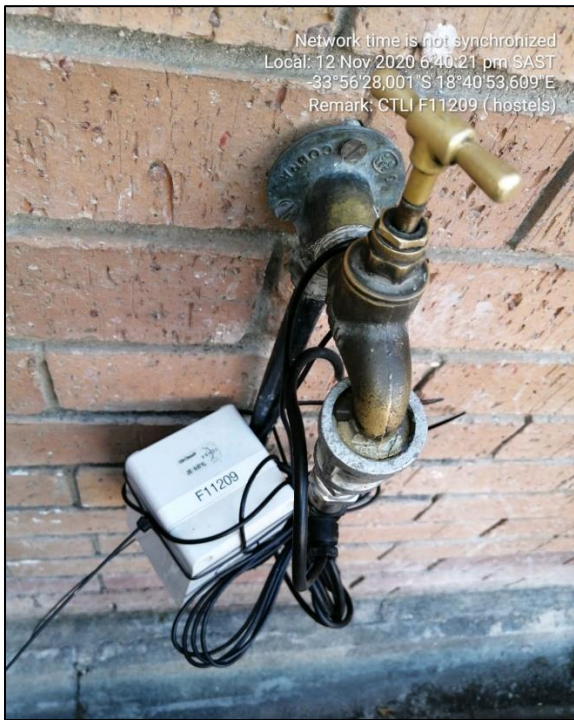
*Pressure Logging*

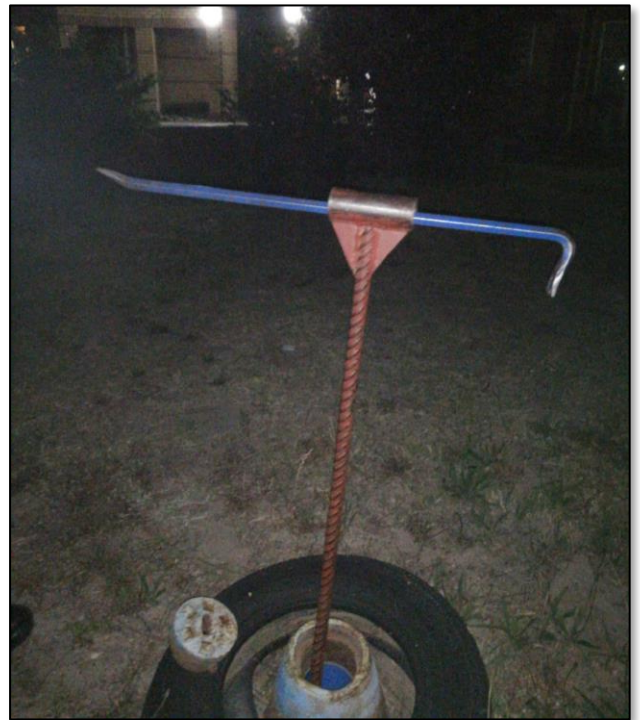
*Zoning*

- **Zoning** – Zoning exercises were executed to reduce the search area and verify that the information gathered was accurate.

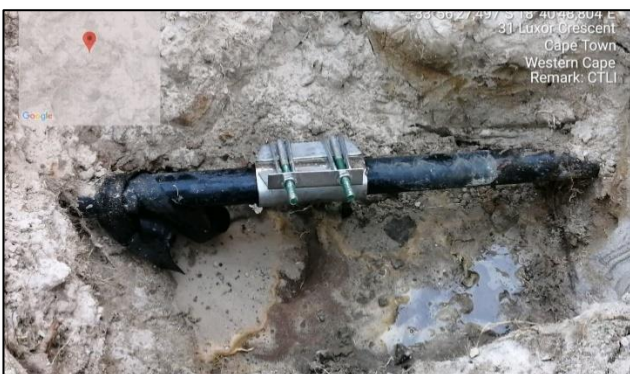
*Leak Detection Repairs*

- **Leak Detection** – Following the implemented of the valve replacement project and the completion of the zoning exercises, a thorough leak detection investigation was implemented by analysing the zoning data and using equipment such Acoustic leak detection, Valve Correlation and Vibration logging. A Ground Penetrating Radar was used to locate pipelines and infrastructure.

- **Leak Repair** – Leaks detected had to be excavated and repaired. The site also had to be reinstated to its original condition.

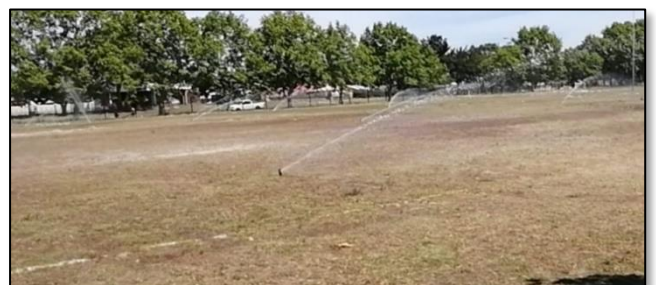
*Irrigation from Borehole Water*

- **Irrigation System** – The borehole and Water Treatment Works was decommissioned, and it was proposed to construct a separate water distribution network from the Water Treatment Works to tie-in with the irrigation system.
