Client Name: Girls and Boys Town

Project Description: Re-Solve was appointed by Girls and Boys Town to assist with reducing their overall water consumption at their Magaliesburg campus, as they had been receiving exorbitant monthly municipal water bills. The campus is over 70 years old, and money had been spent to upgrade the infrastructure, however, frequent leaks and pipe bursts were still a common occurrence. As part of Re-Solve's Corporate Social Responsibility, a discount of R50 000 was provided to Girls and Boys Town on the cost of the work to be undertaken.

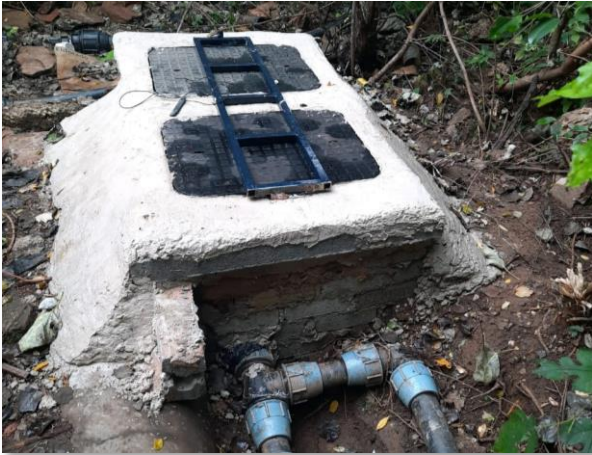
Newly built PRV chamber

- Installation of a new Pressure Reducing Valve – Installing a new 50mm diameter pressure reducing valve to reduce the remarkably high pressure at the campus to acceptable pressure levels. An instantaneous pressure test taken at the high/critical point revealed that the pressure was 6.5Bar and this was where

pressure was expected to be lowest. The proposed PRV would reduce the 6.5Bar at the critical point to 2.5 – 4Bar depending on the requirements.

- Installation of a new 50mm Pressure Reducing Valve, water meter, strainer, and isolation valve. The PRV was set to reduce the incoming water pressure from 16Bar to 3Bar.
- Visual leak detection and repairing of leakages identified from toilets, urinals, and taps.
- Installation of a check meter, sub-meters, and a GSM logger to record water consumption for the whole campus and at various locations within the campus.
- Refurbishment of the existing borehole involving the installation of a new borehole pump and motor, a new borehole cover, new electrical cabling, and isolators.

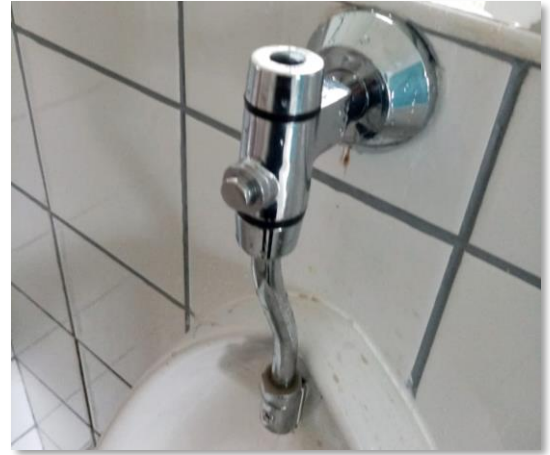
Repaired urinal

- **Leak detection and repairing of leaks** – This followed the installation of the PRV to ensure that no further pipe bursts or leaks occur, after the water pressure has been reduced. This phase was completed through visible leak detection and all the leaks found were repaired

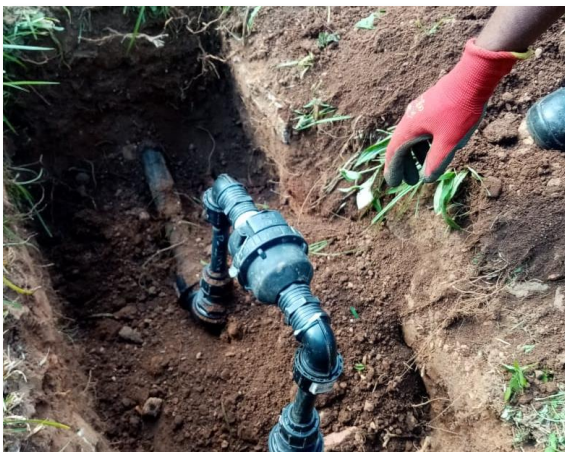
Newly installed 20mm sub-meter

In addition to the PRV installed and leakages repaired, 20mm diameter sub-meters were installed at various locations within the campus. These sub-meters assist campus management to accurately track the consumption of each building and ensures that the area supplied by each sub-meter can be isolated. The Re-Solve team installed a check meter and installed a real-time GSM logger on the meter. The GSM logger transmits water consumption data to a cloud-based platform where it can be stored and accessed remotely. The refurbishment of the water treatment plant was not included in the final approved scope

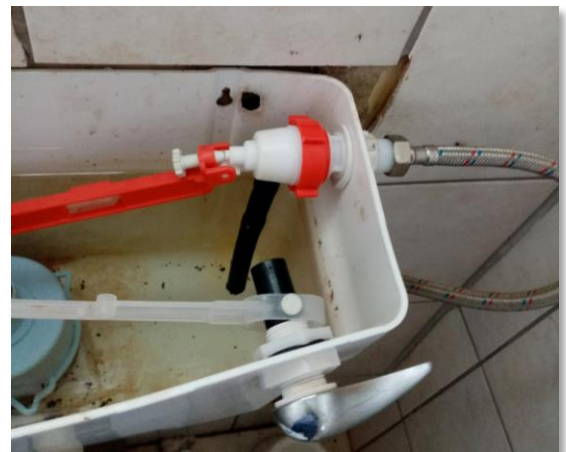
Repaired Toilet cistern
